Advances in the assessment of drystone retaining walls — some case studies

L.A. Warren¹, K.M. Briggs² and P.F. McCombie^{2*}

ABSTRACT Drystone retaining walls have played an essential part in the infrastructure of hilly and mountainous regions around the world, and have provided platforms for building and for agricultural terraces. Research carried out in England and in France has led to a good understanding of their behaviour, but it is difficult to determine the details of the construction of individual walls without dismantling them, and so it can be hard to tell whether or not apparent defects and deformations are a threat to stability. Replacing every apparently defective or deformed wall would be a waste of resources, yet dismantling a wall would obviously be completely disruptive to its function. Invasive investigation, such as drilling, could easily cause damage to the wall structure and destabilise the wall. There is therefore a pressing need for non-disruptive methods of investigation that can reveal critical aspects of a wall's construction. Thermal imaging carried out in the right conditions can reveal important information about aspects of a wall's construction that

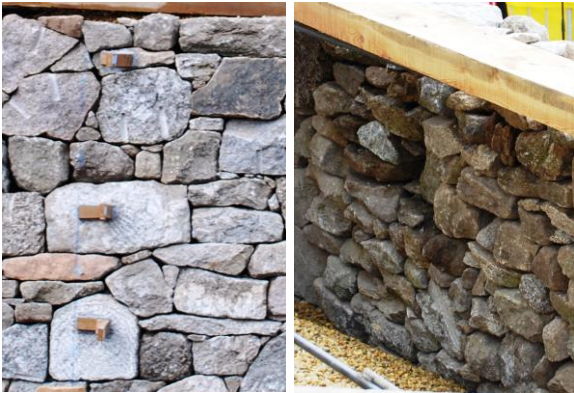
Figure 1. Front and back faces of an experimental wall constructed in France, reflecting normal good practice for construction in granite.

The quality of the stone is however relatively easy to ascertain from visual inspection. The quality of the construction can be concealed. A carefully made stack of blocks will resist earth pressures, but the great strength of drystone walls is their ability to tolerate uneven and variable loading and support, by re-distributing load within their construction via good overlaps between carefully laid stones (McCombie et al. 2012). Because of the retaining function, the vertical load near the front of the wall is greater than that at the back, and this combined with the fact that the front face is what is seen by the client leads to the construction of the face often differing significantly from that at the back, as can be seen in the test wall shown in Figure 1. The wall shown was extremely strong and stable, despite the difference in appear-

ance between the two faces. The builders of this wall rank among the best in the world, and the quality of the construction was very high.

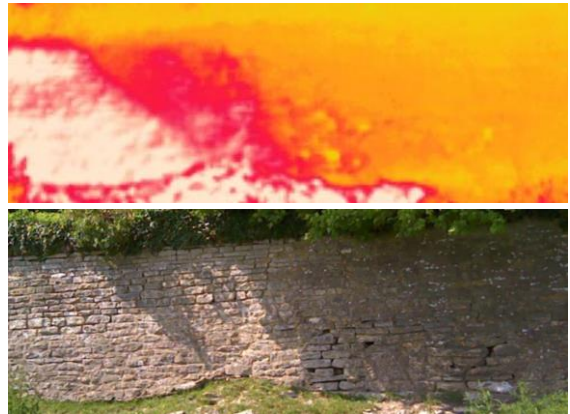
The influence of shading can be a problem for thermal imaging, as shown in Figure 6. Part of the wall is shaded by a large tree, and where this shading occurred very little thermal information could be gathered in comparison to the unshaded adjacent are-

as. This effect was still present once direct sunlight was no longer present on the wall.

Figure 6: Thermal image showing the effect of shading.
